Naam	Name	<b>MACTRA ( 2 )</b>
IMO Nr.	IMO Nr.	6903058
Roepnr.	Callsign	FMRK
Bouwjaar	Build	1969
Werf	Yard	Kieler Howaldtswerke A/G, Kiel, Germany.
Bouwnr.	Build. Nr.	1200
In dienst	In service	1969
Eigenaar	Owner	Soci�t� Maritime Shell France, Parijs.
Vlag	Flag	French
Thuishaven	Homeport	Le Havre.
Type	Type	Tanker
Klasse	Class	LR
Sub Type	Sub Type	Crude
Lengte (o.a.)	Length (overall)	325.33 mtr.
Lengte (p.p.)	Length (p.p.)	- mtr.
Breedte	Beam	47.17 mtr.
Holte	Depth	24.52 mtr.
Diepgang	Draft	- mtr.
Tonnage DWT	DWT	206.885 ton
Tonnage GT	GT	156.802 ton
Tonnage NT	NT	171.000 ton
Inhoud	Cubic	330.787 m3
Machine(s)	Engine(s)	2 A.E.G. steamturbines.
Vermogen	Output	28.000 Hp
Snelheid	Speed	15.0 mile
Verbruik	Consumption	- t/h
Aantal Tanks	Total Tanks	8 center, 5 wingtanks, 2 clean ballasttanks.
Bijzonderheden	Remarks	<b>Mactra (1)</b> (6.193 ton) build in 1936 by Swan Hunter & Wigham Rich., Wallsend, for Shell Tankers UK.

## ss Mactra

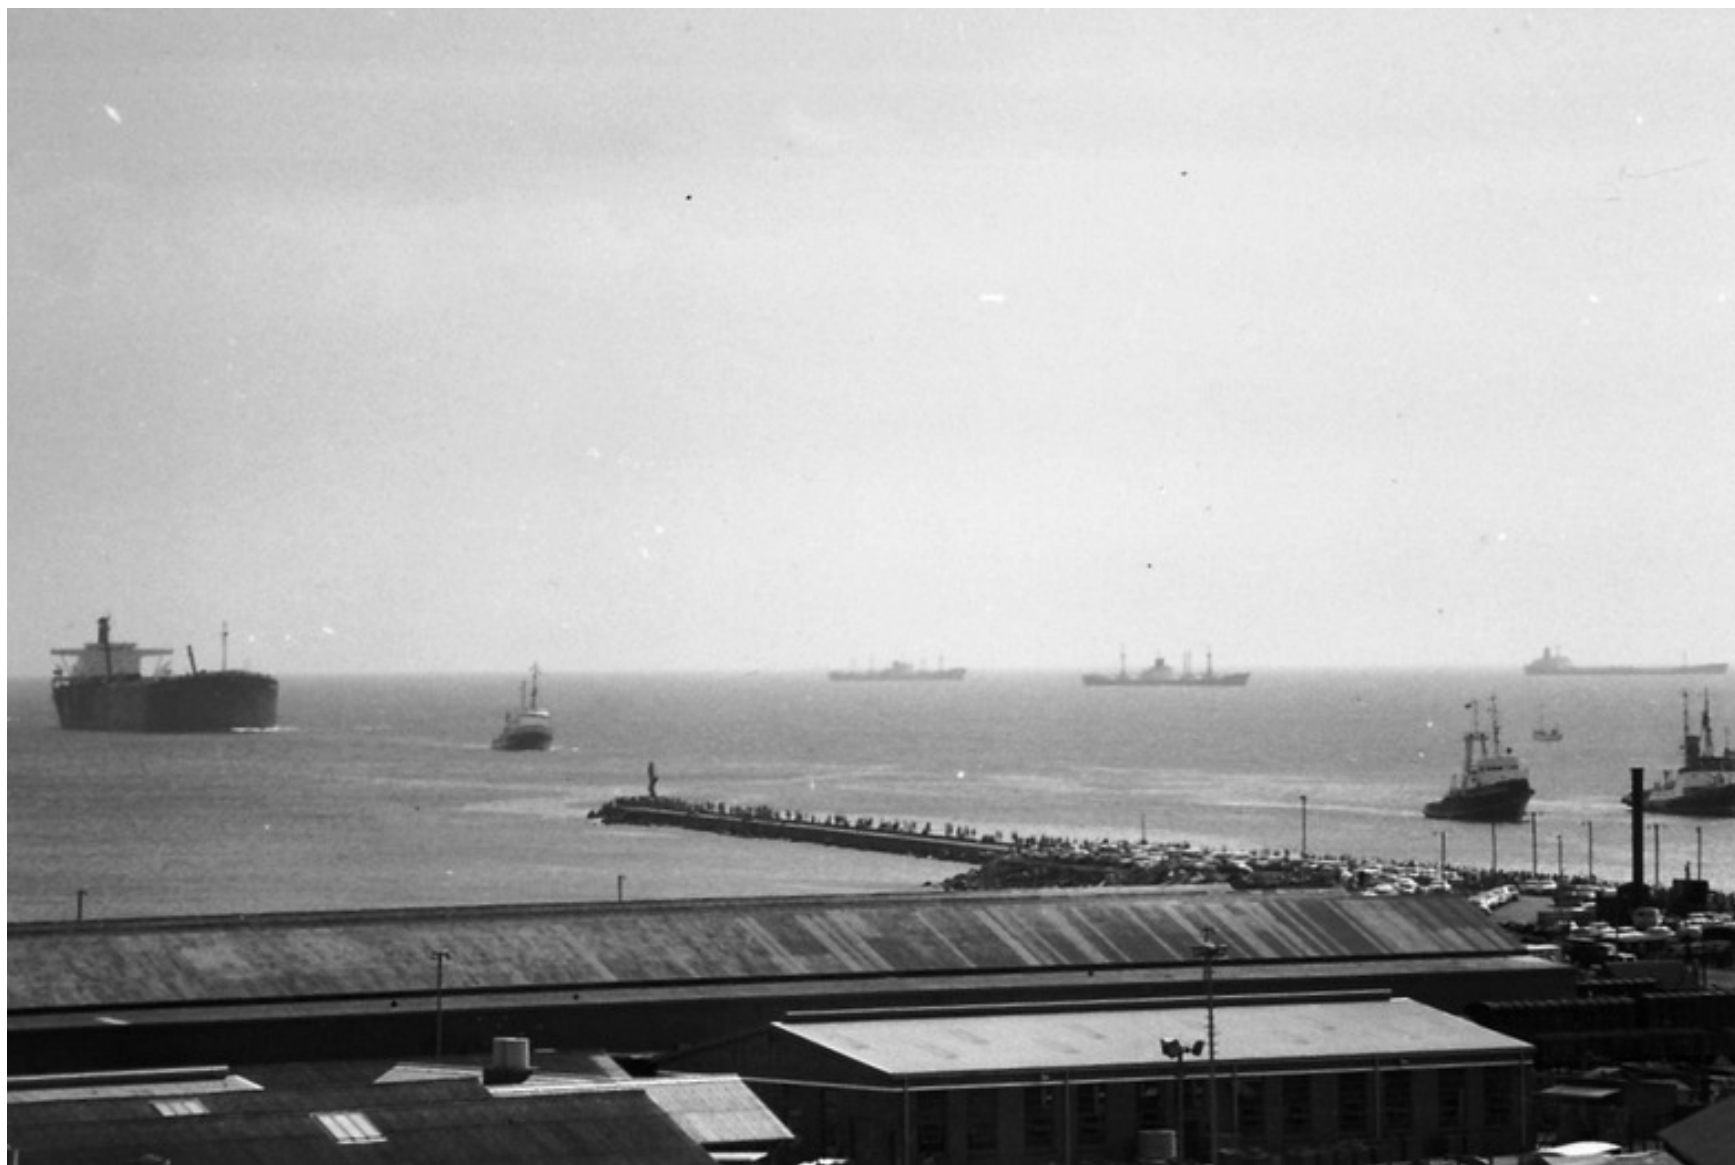
Januari 1970. Vanaf de *Straat Magelhaen* wordt de *Mactra* gespot bij aankomst Durban. De *Mactra* wordt geëscorteerd door sleepboten voor en achter.

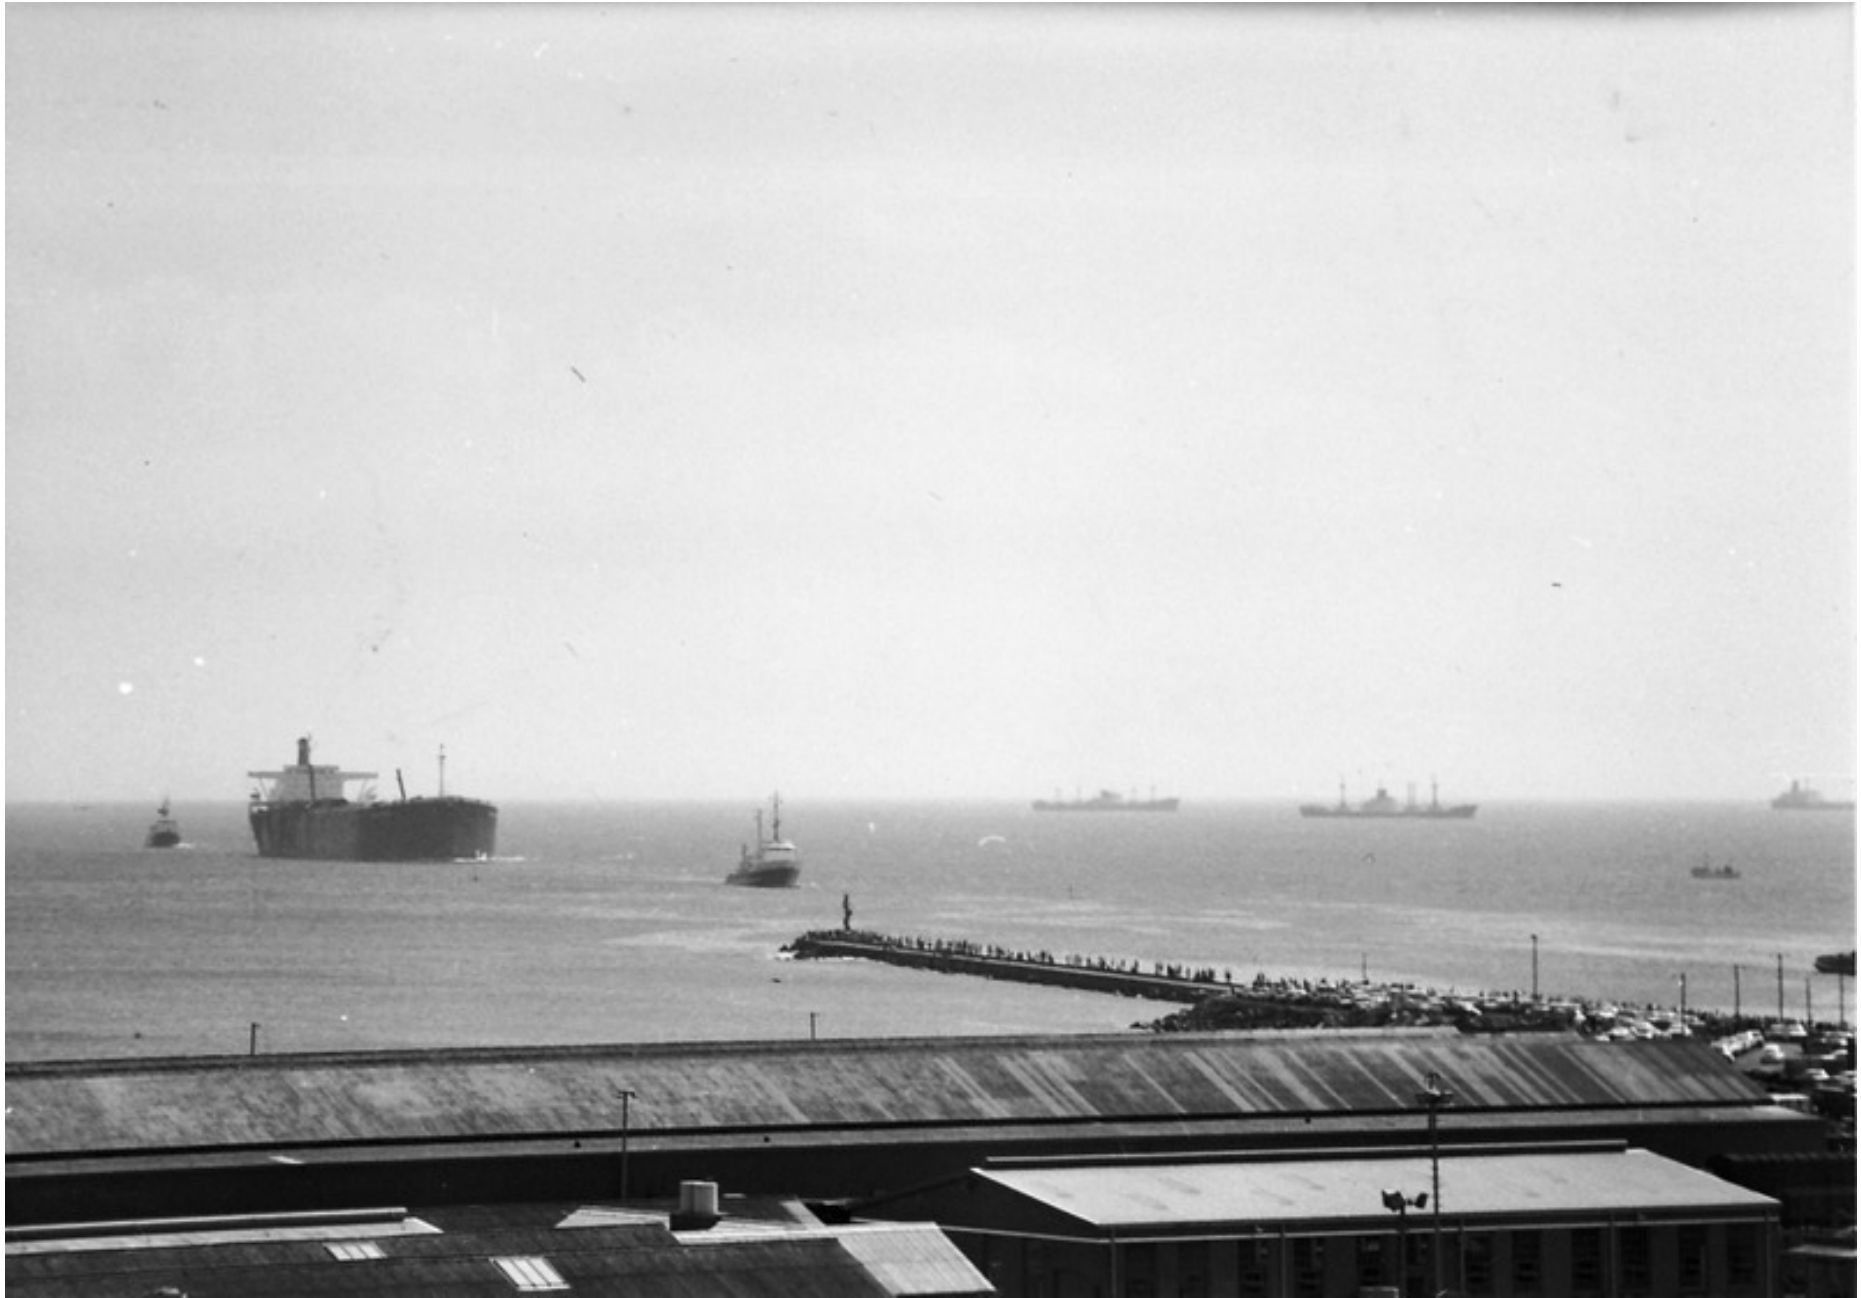
Veel  
publiek  
op de  
wal en  
in  
bootjes  
op het  
water.
